Blending in a Crooked Dormer

BY IAN SCHWANDT

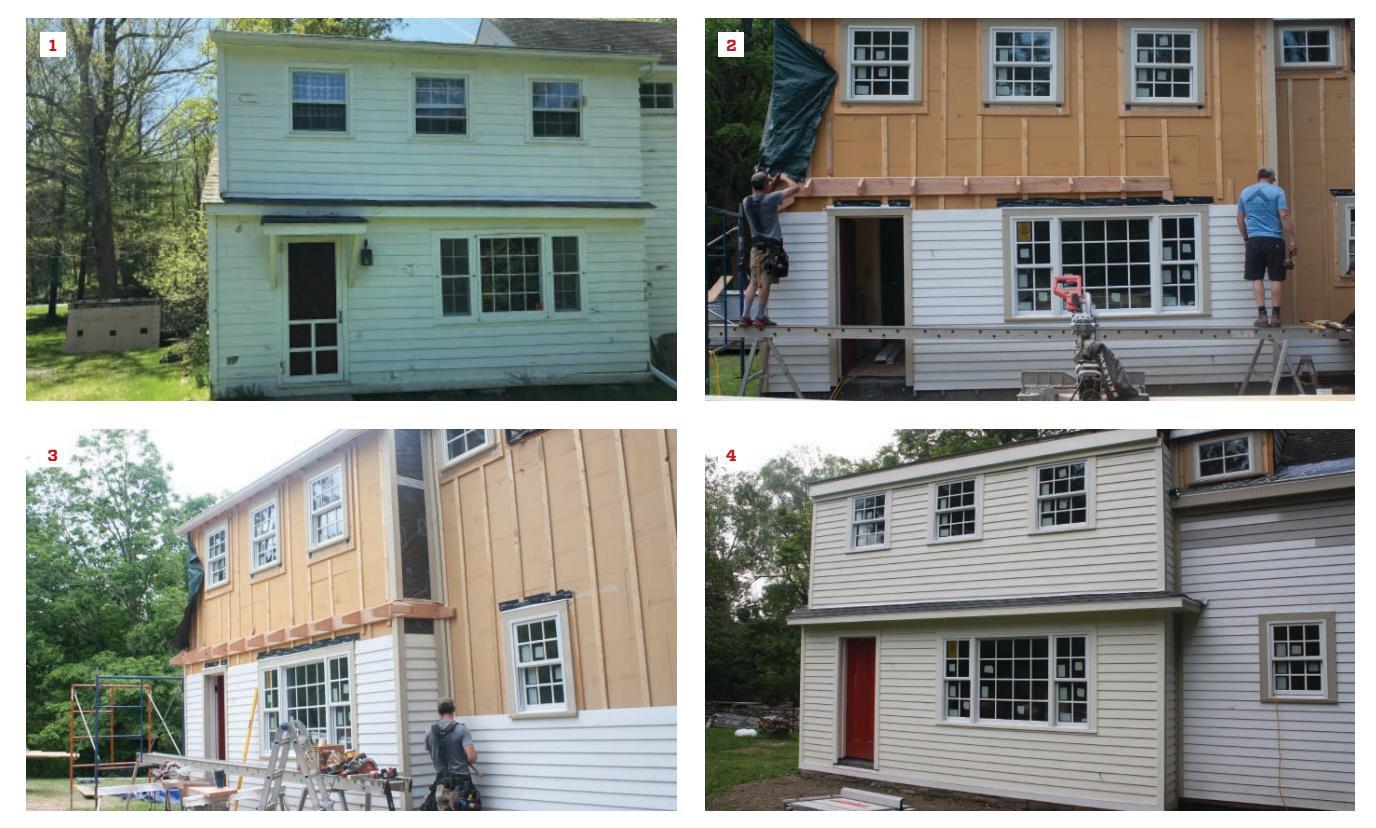
The original sagging dormer and roof/soffit revealed the building's out-of-whack nature to the eye (1). The crew packed out the wall with Gutex insulation and strapping, then fastened on a new tapered roof/soffit frame (2, 3). The finished facade blends the upper and lower structures together more harmoniously (4).

The second floor dormer and its flat roof are out of level 5 1/16 inches left to right across about 21 feet. It is set back from the firstfloor elevation 8 inches, and the resulting rake roof section carries around and divides the dormer from the first floor below. This soffit was parallel to the out-of-level flat roof. Our scope of work included replacing the three second story windows and the first floor window, sheathing with CDX plywood, installing Gutex insulation, and finally, applying new clapboard siding with a rain screen detail. All were straightforward tasks—but how to make it look right?

After demo, which included removing the bisecting soffit up to the rake, we completed the scopes of work that brought us to the second-floor window install. The existing windows were installed out of level, but in a way that they stepped down across the wall elevation. We opted to install the new windows square, with the heads parallel to the out of level dormer roof, which gave the interior trim a cleaner look. The new first floor window, at nearly 8 feet in length, left us no option other than to install it level.

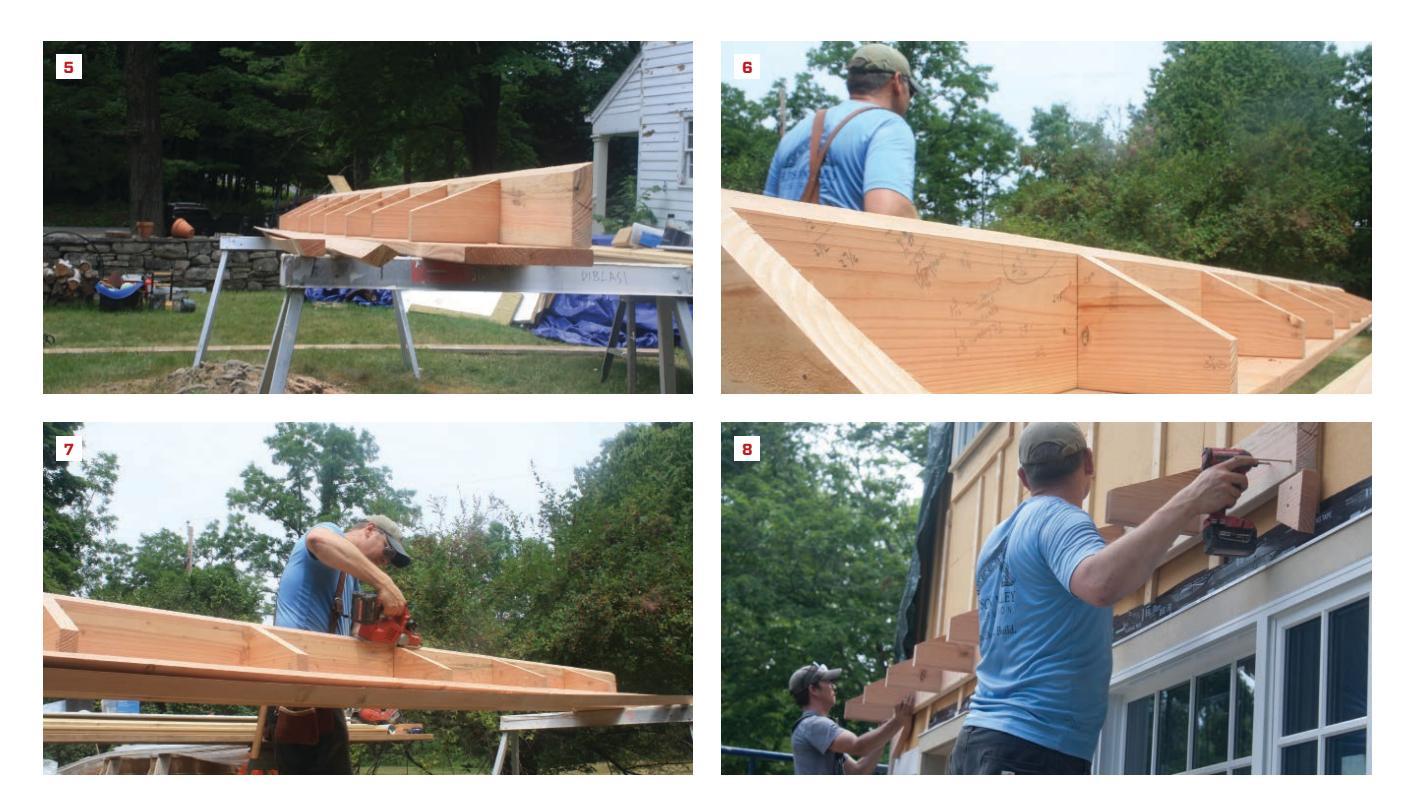
To accomplish the 2-1/2-inch drop over the width of the building face, the author calculated a 1/4-inch decrease per rafter (1, 2). He ripped the ledger board on a 29-degree angle and hand-planed the board to match the descending rafter angles (3), ending with a bevel of 18 degrees, which matched the angle of the right-hand side rake.

The intersection of the left side rake with the face of the dormer set the layout for the peak and the fascia height set the bottom of the soffit. Knowing that I needed to drop the peak 2 ½ inches over 21 feet, I plugged those numbers into my Trig Solver App and found that the roof peak dropped at a 0.5685-degree angle. Using this angle along with my desired 24-inch rafter spacing, the Trig Solver App gave me a drop in rafter peak elevation of 0.2381 inch, rounded off to ¼ inch per rafter.

We built the roof/soffit assembly in three sections on the ground before attaching it to the wall. After laying out the 24-inch rafter centers I subtracted the ¼ inch in height and snapped a line through for the peak angle and ripped it at the 29-degree angle of the left side rake. After installing the rafters, which were laid out individually and free hand cut on the table saw, I used an electric planer to flatten the 29-degree angle to match the angle of each rafter. The last rafter at the 21-foot mark had dropped to a rake angle of 18 degrees. To complete the roof section I carried the roof around the corner at the same 18 degrees to place the hip in plane with the end of the roof section.
